Manhole Inspection Summary

Manhole # S53M__055MH

Insp Date: **4/7/08 10:03 AM**

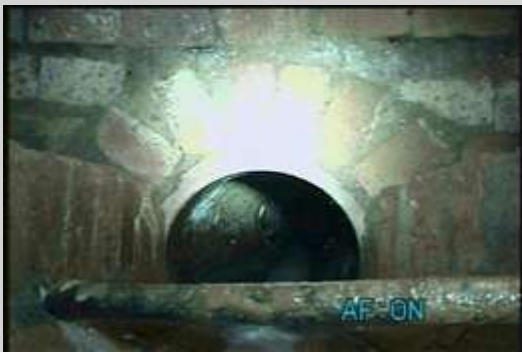
12 O'Clock Outflow

8 in. Circular Gravity Sewer
Pipe Out @ 12 O'Clock

Invert Depth: 9.30 (ft.) Flow Characteristics: **Slow**

Deposits: ☒ None ☐ Mud ☐ ~~Sludge~~ ☐ Debris ☐ Grease

Infiltration: **None** Pipe Seal Cond: **Unknown**

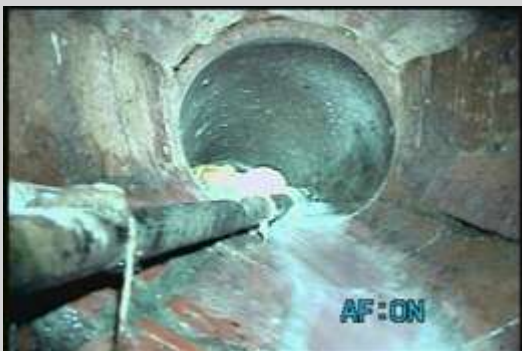
3 O'Clock Inflow

8 in. Circular Gravity Sewer
Pipe In @ 3 O'Clock

Invert Depth: 9.00 (ft.) Flow Characteristics: **Slow**

Deposits: ☐ None ☐ Mud ☒ ~~Sludge~~ ☒ Debris ☐ Grease

Silt Depth: 2 (in.) Deposits Extent: **Medium**

Infiltration: **None** Pipe Seal Cond: **Unknown**
